TAN BURRUP PROJECT	02080

TAN BURRUP PROJECT COMPLIANCE ASSESSMENT REPORT (MS 870)	PAGE 1 OF 1	
	2-250-329-REP-TRE-8001-Att10	REV.: 02

Monitoring on PM10 at Rock Art sites

Air Quality Monitoring Report at CSIRO rock art sensitive receptors

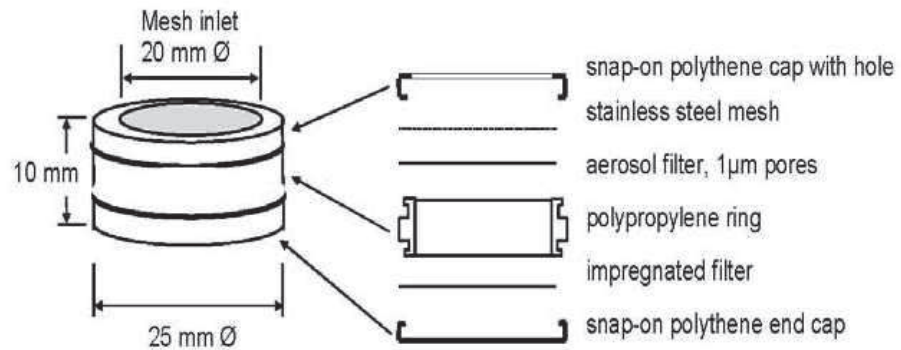
Figure 1. A passive gas assembly.

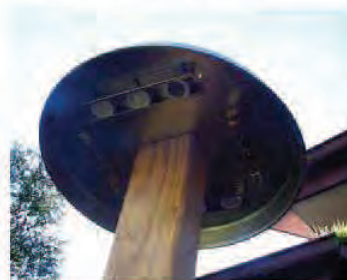
Figure 2. Passive gas weather shield.

- A star picket or wooden post at least 1.5 m high should be installed at the site and an anodized aluminium sample holder is screwed to the top. The holder, shown in Figure 2a and 2b, acts as a weather (rain) shield for the sampler. Up to 8 samplers can be installed in the in the two rails on the underside of the holder.

Figures 2a and 2b. An anodized aluminium sample holder.

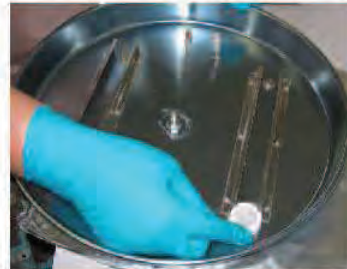
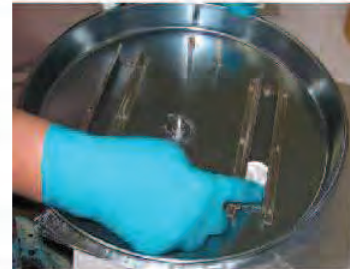
- To commence sampling, remove the passive sampler from the storage vial. Handle the sampler by holding the plastic barrel. **The sample end containing the mesh and/or filter is the inlet through which gases enter. Care should be taken to not touch this end. If the mesh and/or filter is accidentally pushed in during handling, do not use the sampler.**
- Unscrew the wing nut at end of the rail on sample holder. Remove screw. Slide sampler into rails so mesh inlet faces the air. Reattach screw and wing nut.

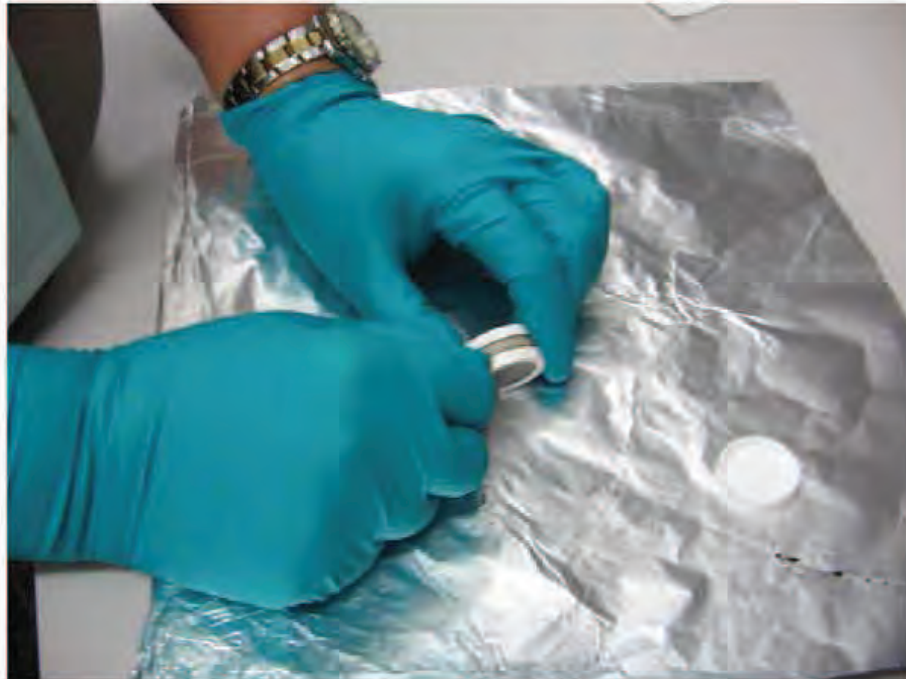
Figure 3. Lay out aluminium foil. Wear gloves. Prise the mesh cap off using gloved hands.

- Take the exposed ammonia samplers in their vials to a clean bench in an indoor work area that does not contain any obvious ammonia sources (e.g. cleaning products, etc).
- Wear the disposable gloves supplied.
- Lay out the clean sheet of aluminium foil supplied.
- Open the vial of one exposed sample and tap gently to remove.
- Gently prise off the mesh snap-on cap, which contains the aerosol filter using gloved hands. See Figures 3 and 4.

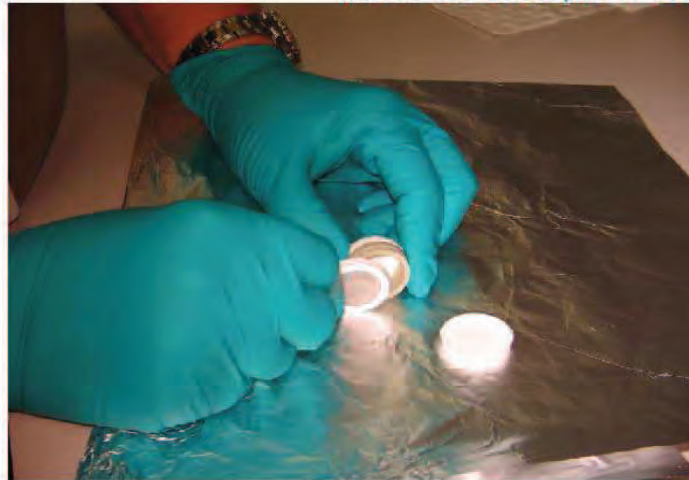
Figure 4. Remove the mesh cap, which contains the aerosol filter.

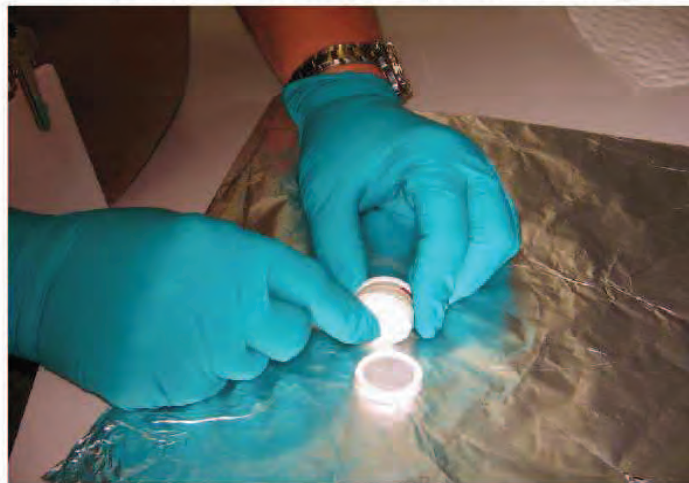
Figure 5. Pick up clean cap and place on sample inlet.

- Replace with a clean white plastic cap supplied. Push the cap so it snaps onto the ring. The sampler should now have closed plastic caps on both ends. See Figures 5 and 6.

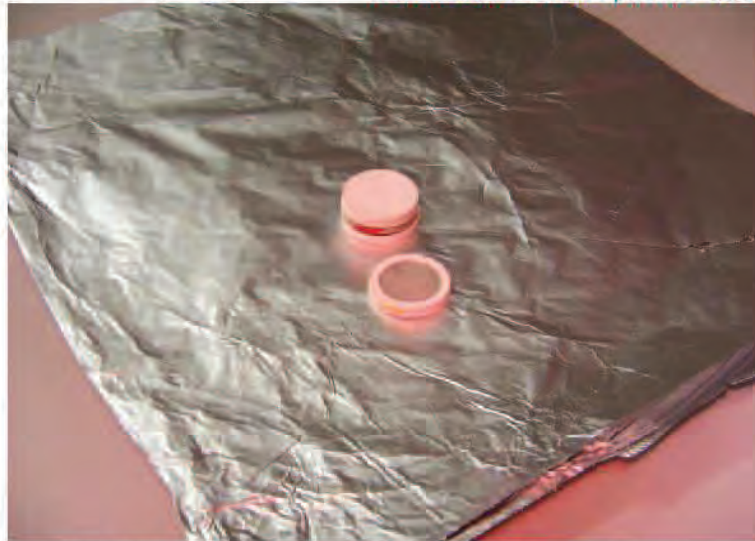
Figure 6. The sampler should now have closed plastic caps on both ends.

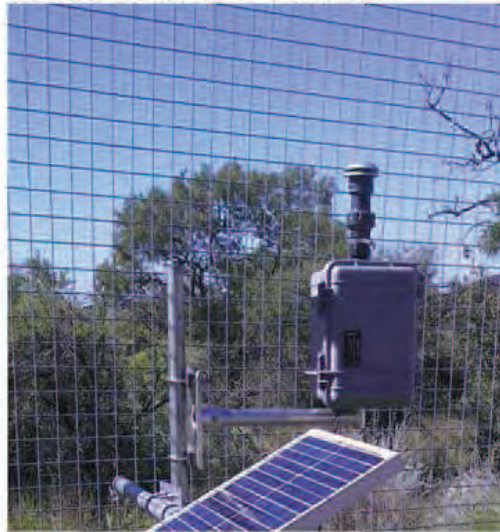
1. MiniVol – dust monitoring, runs once every 6 days. The run days are same all over Australia, and the next run day is 24 August 2013 than 30 August 2013 and so on. The 47 mm filters to be used with the minivol have to be weighted before and after exposure the difference than has to be divided by the amount of air in 24 hours base on the 5l/min flow. All the calculation formulas are very well explained in the TAS MiniVol manual left with the Laboratory Staff. The filter weighting has to be done in a controlled environment for temperature and humidity (practically the whole set up including the microbalance has to be kept at same temperature and humidity).

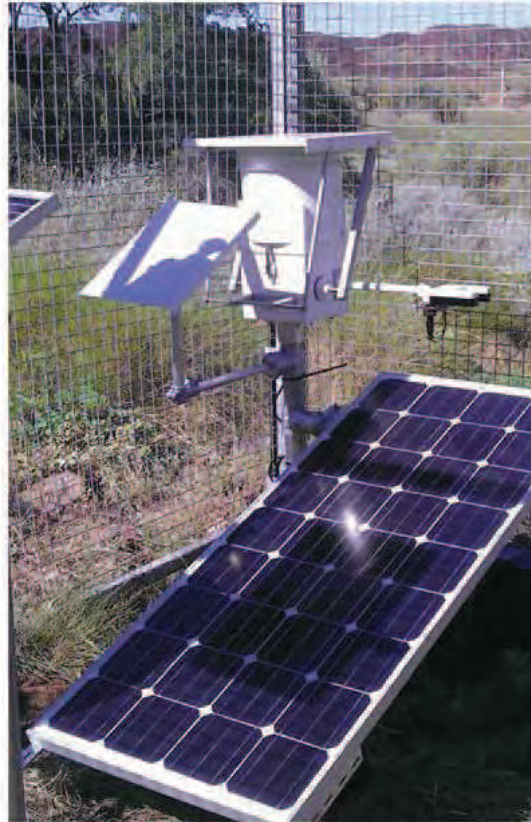
Wet Precipitation Sampler – the buckets have to be primed as instructed by CSIRO and be exposed in the field for one month at the time. At the end of the month the buckets have to be changed with a fresh one and the exposed bucket have to be sent for analysis (CSIRO)

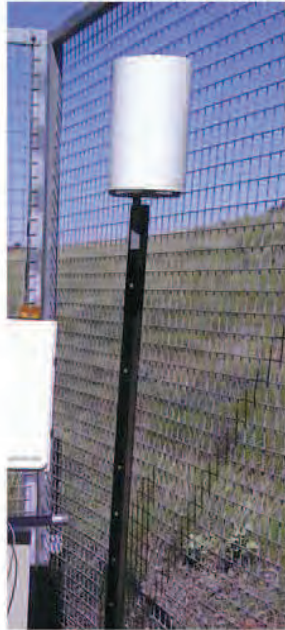
3. Dust Deposition Bottle – the bottle has to be primed with the same chemicals as for the Rain Water sampler and exposed in the field for one month. After one month the bottles have to be collected, new bottles installed and the exposed bottles have to be analysed for “Total solids”. The mining industry standard calls for the results to be below 5miligrams/m2/month. If the resulta are exceeding this value, I recommend to ask a laboratory like ALS to perform an “Ash analysis” which will reveal only the mineral matter deposited over the month.

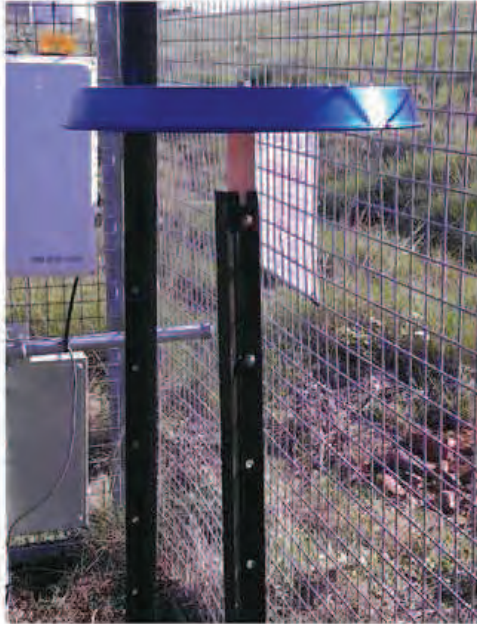
4. Gas analyser – supplied by CSIRO – exposure and analysis as required by CSIRO

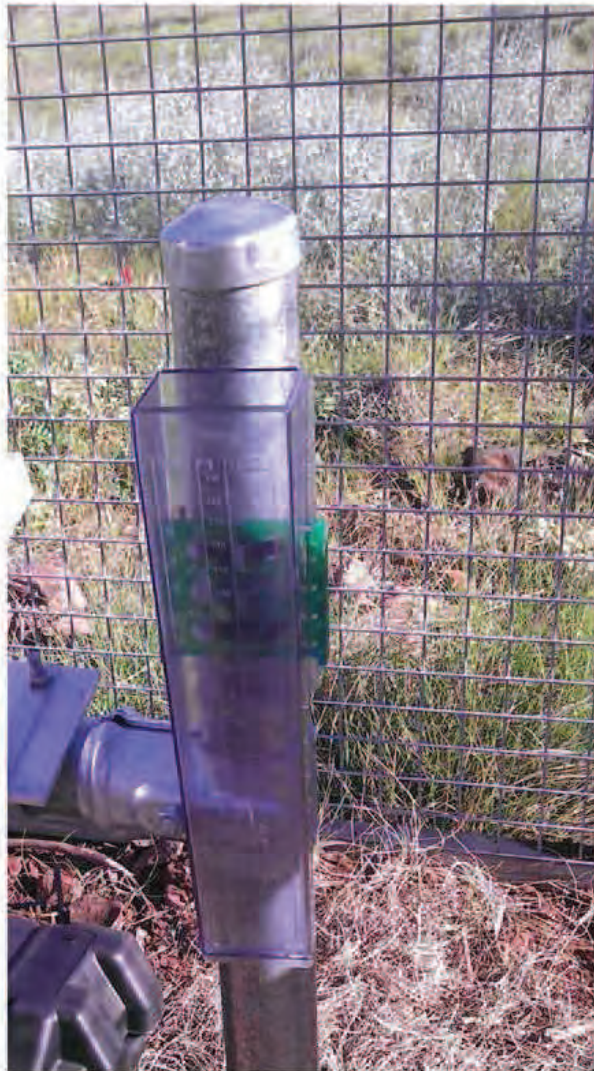
5. Rain Gauge – used to measure the amount of rain over a period of time – I suppose over a month. When the bucket of the wet rain sampler is collected, read the amount of rain as indicated by the level in the little tank, record this figure than empty the tank and expose for another period of time.

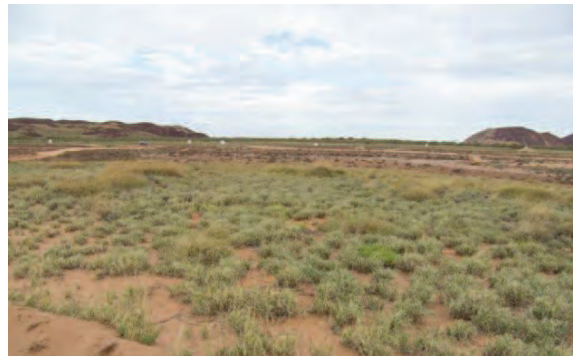
Figure 4.1-1 Buffel Grass (*Cenchrus ciliaris*) with some clumps of *Spinifex (Triodia sp.)*

On the 25th and 26th of May 2013 the TAN Burrup Project Area was traversed to develop the baseline weed survey and the weed species were mapped. Of the three species identified as occurring in the project area prior to clearing, only two, *Cenchrus ciliaris* (Buffel Grass) and *Aerva javanica* (Kapok Bush) (Figure 4.1-1 and Figure 4.1-2, respectively, were encountered during the survey).

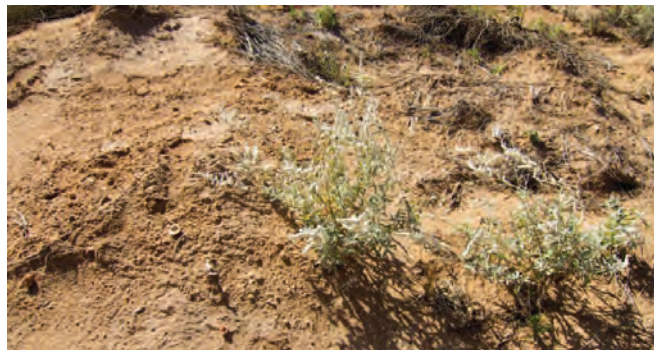
Figure 4.1-2 Kabok Bush (*Aerva javanica*)

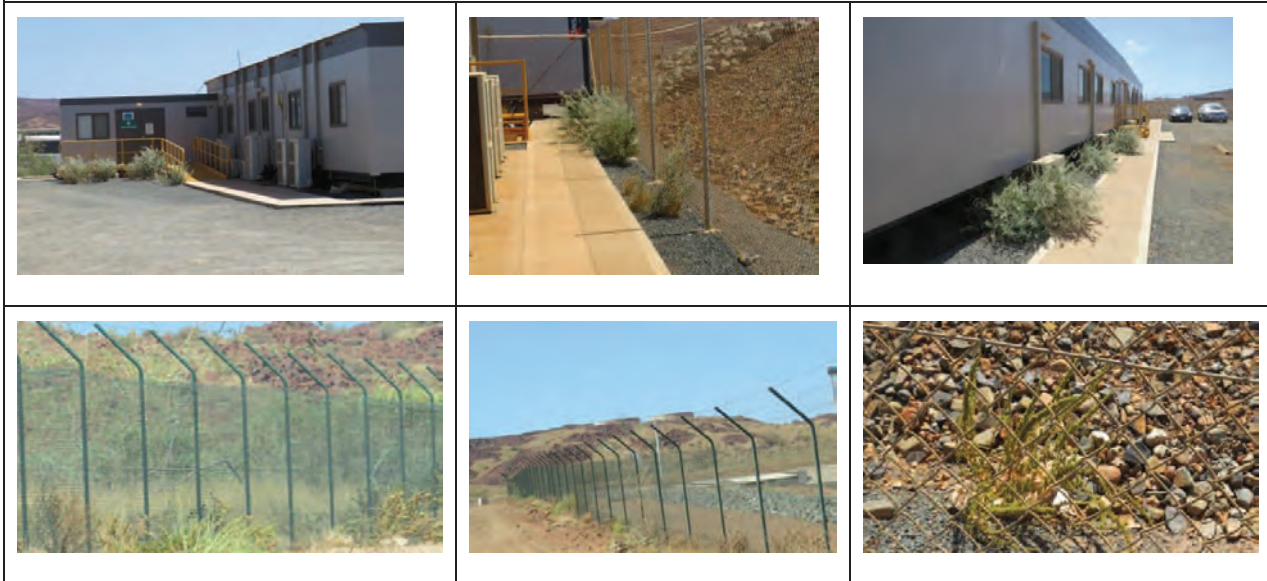
The inspections results are that re-occurrence of same weed species around the Temporary Site Facilities (around main office building) and along the fence mapped have occurred.

Figure 4.2-1 Kabok Bush (*Aerva javanica*), *Cenchrus ciliaris* (Buffel Grass) and Birdwood grass

From June 2014 - December 2014, KAPOK BUSH infestations and some traces of BUFFEL GRASS have been identified in the Temporary Construction Facility (TCF), septic tank area and diesel generator area, both serving the Temporary Main Office. In addition along the fence, it was observed that some weeds outside the fence are starting to spread to the inner plant of the fence and monitoring will be prioritise in this areas for the following six months.

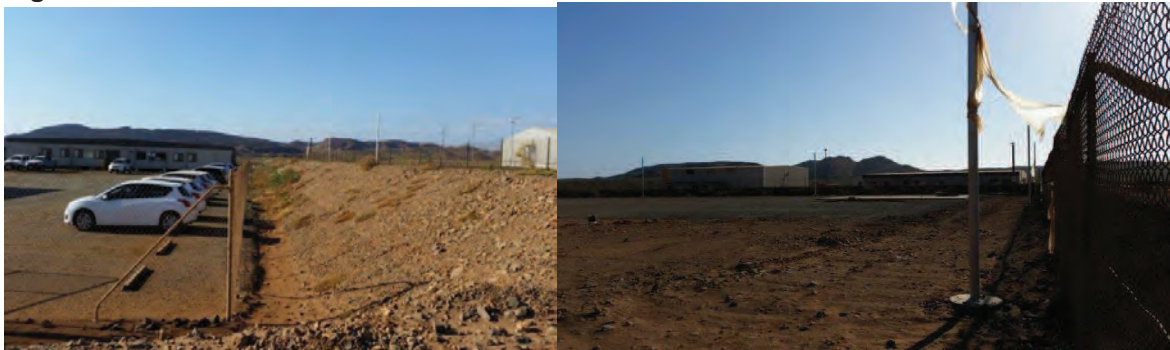
Figure 4.3.1

The inspections results are that re-occurrence of same weed species around the Temporary Site Facilities (around main office building) and along the fence mapped have occurred.

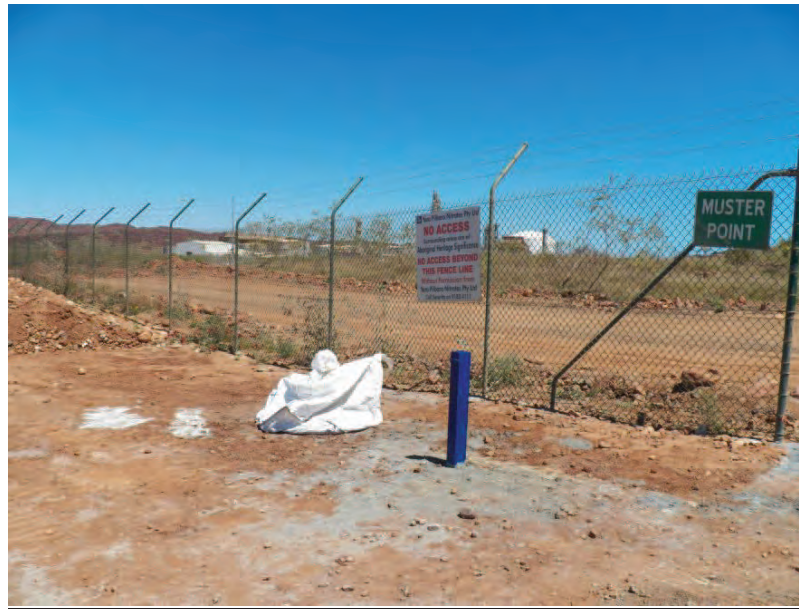
New MW1

New Groundwater wells to replace MW1 and MW4.

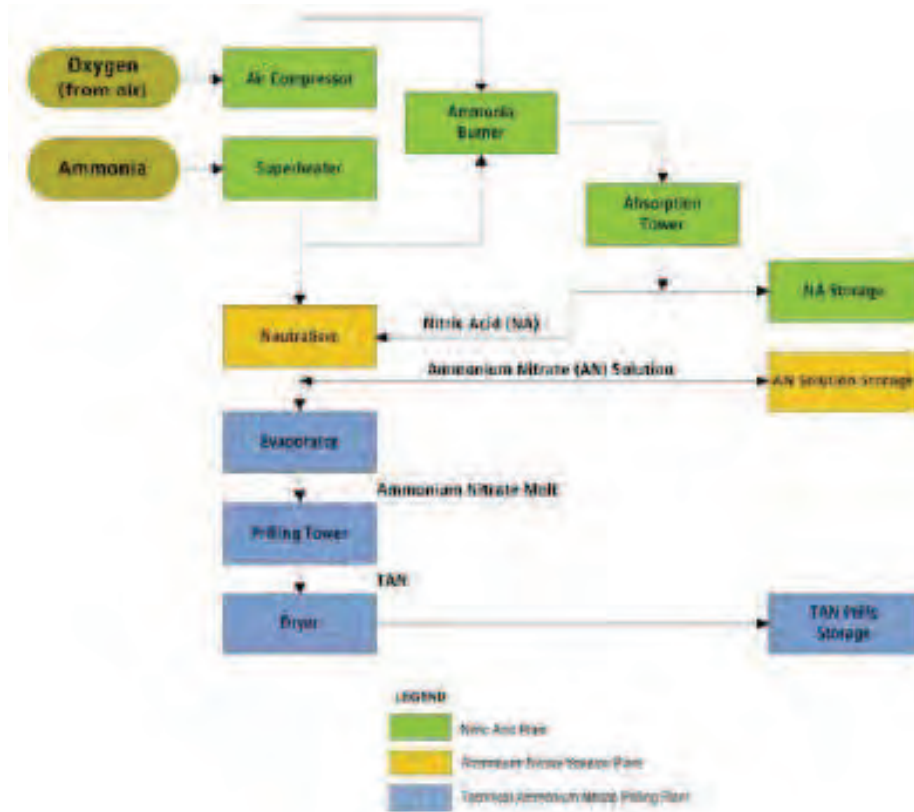
Figure 1.- TAN Burrup Production Process.
